## Brake Line Staining

ADVISORY-002

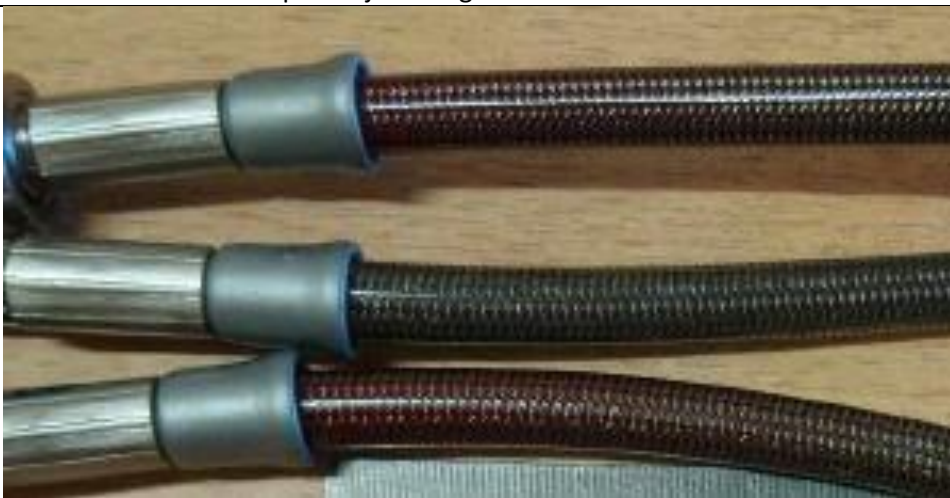
Numerous brake lines have been replaced due to staining that was noticed near the end fittings on the steel braided brake lines with plastic jacketing.

***There is no conformity issue, operational issue, or safety issue related to this observed staining. The brake lines should be used as is.***

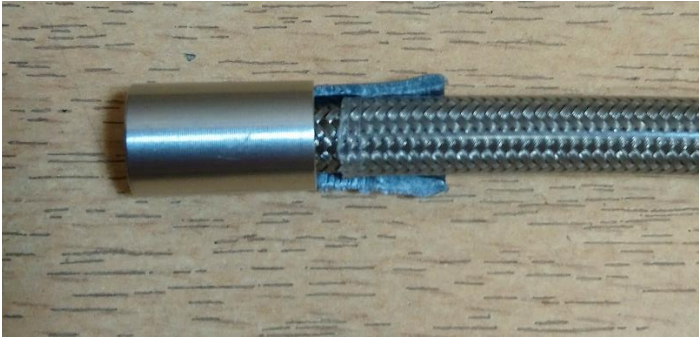
<p>The compression fitting and plastic radius guide are then slid over the steel braided brake line.</p>	 
<p>The desired end fitting is then inserted into the plastic inside the steel braided line and the assembly is crimped.</p>	
<p>During installation, bleeding, or maintenance, it is possible for a small amount of brake fluid that is outside of the system to run down the outside of the plastic jacketing and into the radius guide. As shown in the picture of the cut-away of the radius guide, the brake fluid would be able to contact the steel braided brake line and then be wicked upwards between the steel braid and the plastic jacketing. The near microscopic amount of space between the steel braid and the plastic jacketing means that a few drops of brake fluid can stain a couple inches of brake line jacketing.</p>

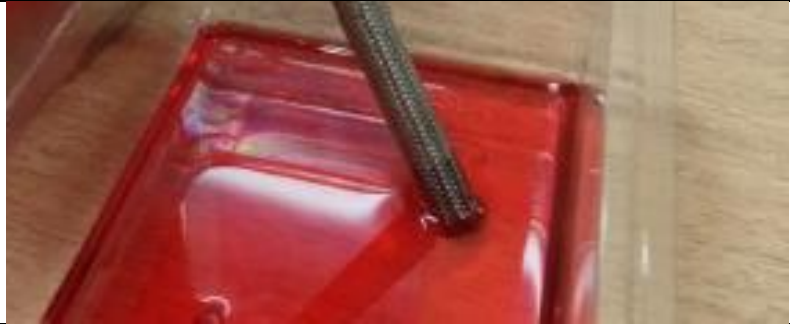
The effects of capillary action are immediately noticed when a brake line is placed in a small amount of brake fluid. The fluid is immediately wicked upwards between the steel braid and the plastic jacketing.

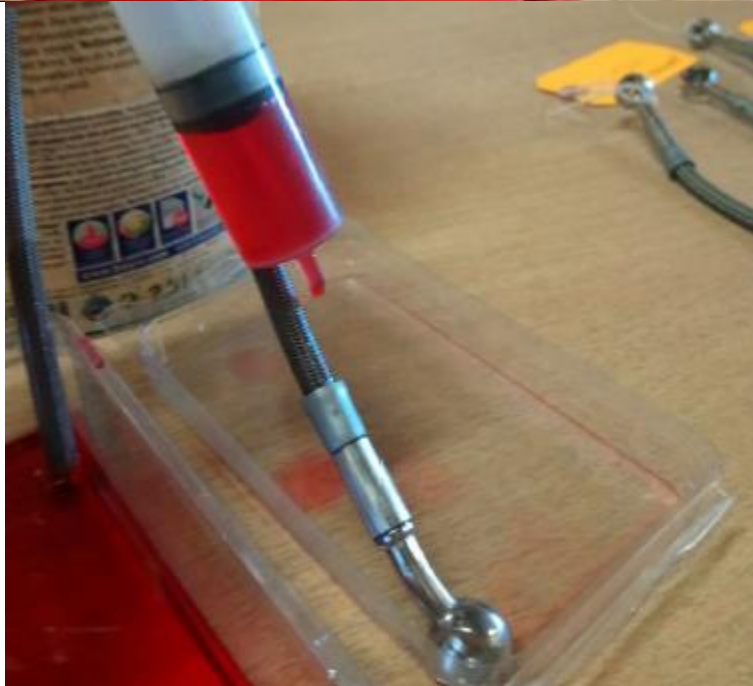
To create a more realistic simulation, 5 drops of fluid were dropped on the brake line just above the radius guide.

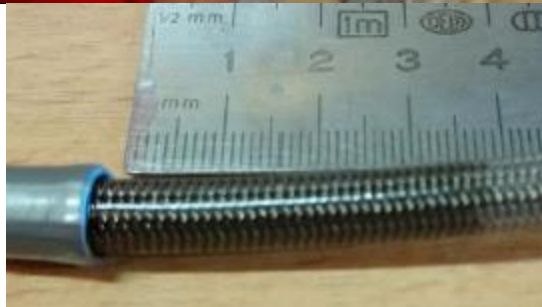
These 5 drops resulted in 3.5 cm of stained brake line within minutes. After a few days the plastic jacketing began to take on a maroon hue.
