SERVICE BULLETIN

SB-017

Replacement of Backstop BTR-002 in order to put the cotter-pin (ISO1234) backward. The goal is to prevent scratching of the inner wheel half by the tails of the cotter pin.

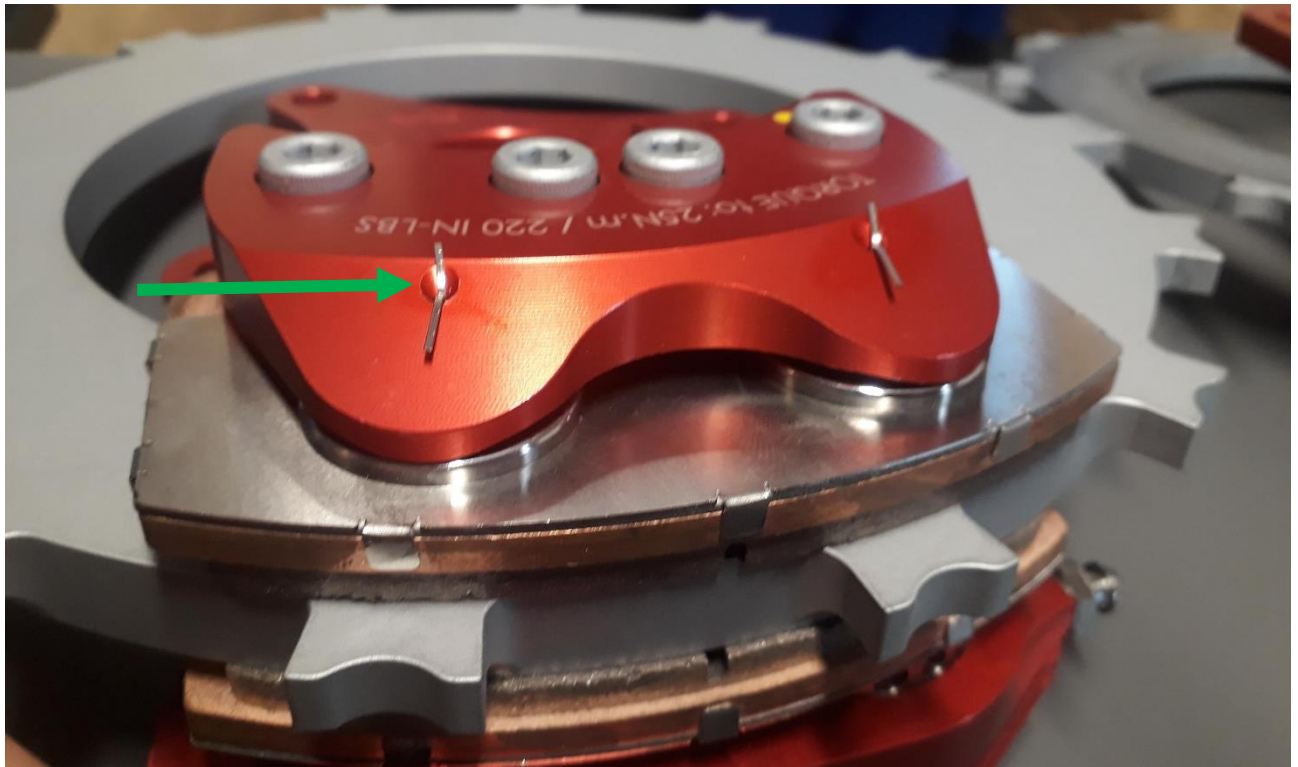
The cotter pin securing the back stop on the brake assembly back plate can be displaced from the as installed position. This can occur during unpackaging and first installation, maintenance, or at any other time when the parts are handled. If the cotter pin tails are raised from the surface of the back plate or rotated 90° from the initial orientation then they are at risk for contacting the inner wheel half and scratching the anodized finish.

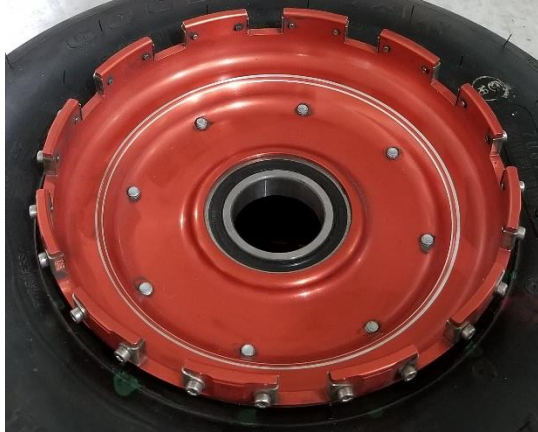
- Remove the wheel and tire assembly per the instructions in the applicable maintenance manual.
- Inspect the inner wheel half for circular scratches. An inner wheel half with a continuous circular scratch that has removed the anodizing must be replaced.

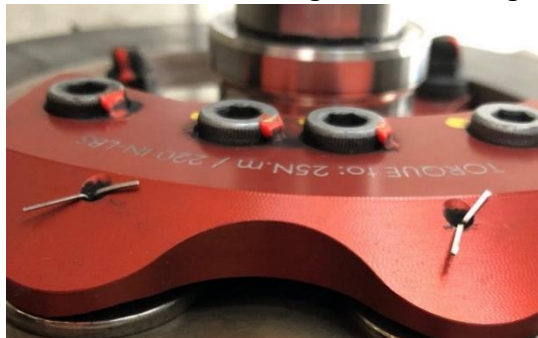
- This scratch has been caused by cotter pins that have been displaced from the initial orientation which is set and controlled during manufacturing.
