SERVICE BULLETIN

SB-019

Replacement of Backstop BTR-001 in order to put the cotter-pin (ISO1234) backward. The goal is to prevent scratching of the inner wheel half by the tails of the cotter pin.

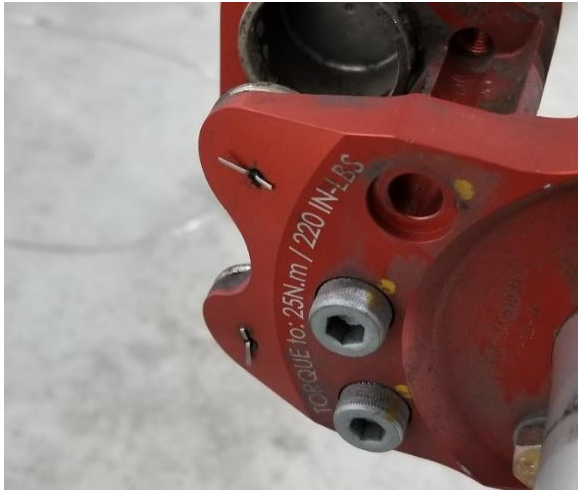
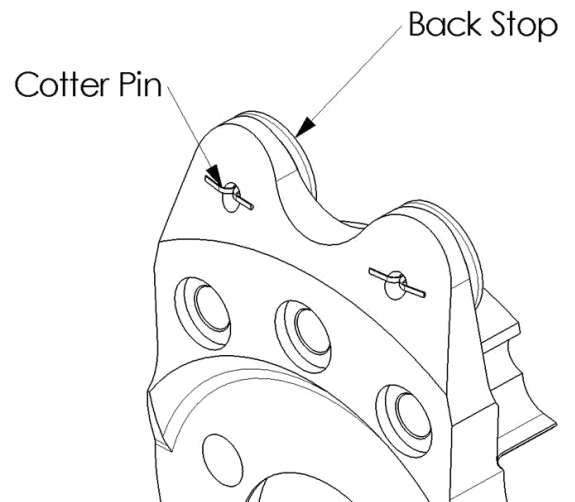
The cotter pin securing the back stop on the brake assembly back plate can be displaced from the as installed position. This can occur during unpackaging and first installation, maintenance, or at any other time when the parts are handled. If the cotter pin tails are raised from the surface of the back plate or rotated 90° from the initial orientation then they are at risk for contacting the inner wheel half and scratching the anodized finish.
