SERVICE BULLETIN

SB-019

Replacement of Backstop BTR-001 in order to put the cotter-pin (ISO1234) backward. The goal is to prevent scratching of the inner wheel half by the tails of the cotter pin.

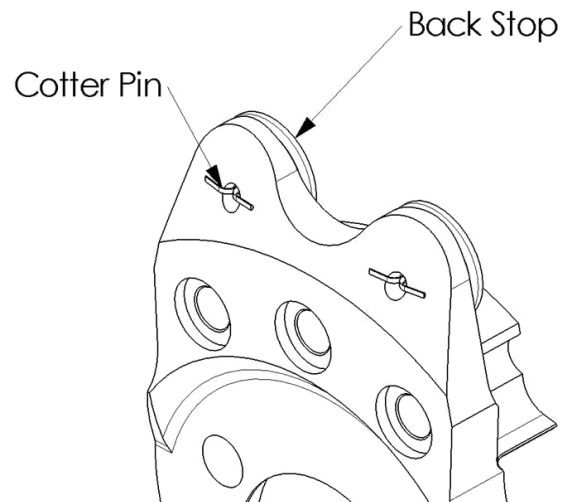
The cotter pin securing the back stop on the brake assembly back plate can be displaced from the as installed position. This can occur during unpackaging and first installation, maintenance, or at any other time when the parts are handled. If the cotter pin tails are raised from the surface of the back plate or rotated 90° from the initial orientation then they are at risk for contacting the inner wheel half and scratching the anodized finish.

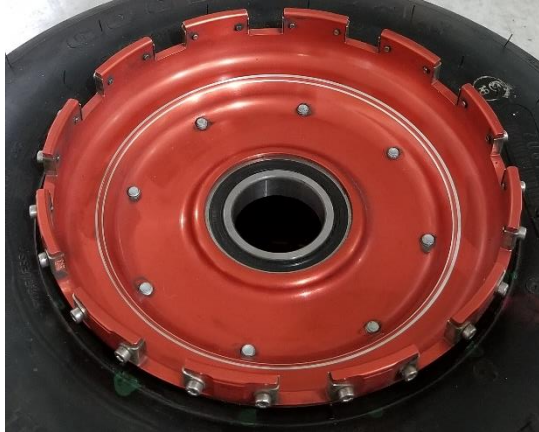
- Remove the wheel and tire assembly per the instructions in the applicable maintenance manual.
- Inspect the inner wheel half for circular scratches. An inner wheel half with a continuous circular scratch that has removed the anodizing must be replaced.

- This scratch has been caused by cotter pins that have been displaced from the initial orientation which is set and controlled during manufacturing.
