SERVICE BULLETIN

SB-015

Replacement of cotter pin (ISO1234) to prevent scratching of the inner wheel half.

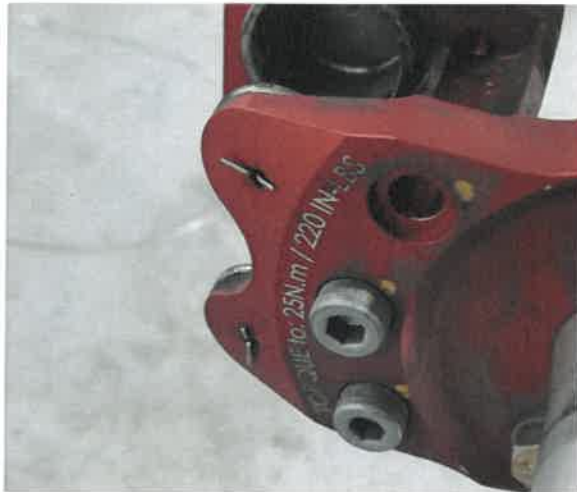
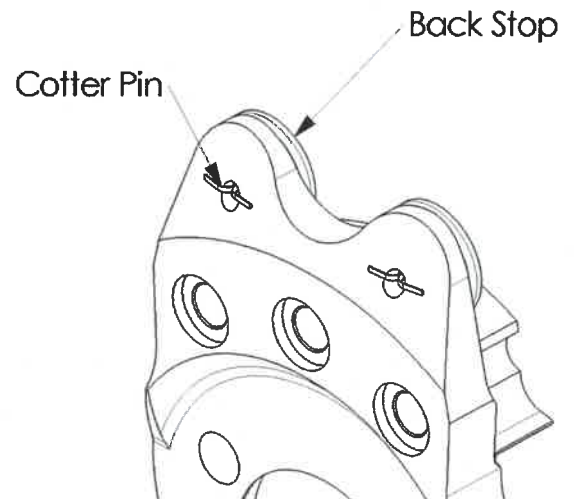
The cotter pin securing the back stop on the brake assembly back plate can be displaced from the as installed position. This can occur during unpackaging and first installation, maintenance, or at any other time when the parts are handled. If the cotter pin tails are raised from the surface of the back plate or rotated 90° from the initial orientation then they are at risk for contacting the inner wheel half and scratching the anodized finish.

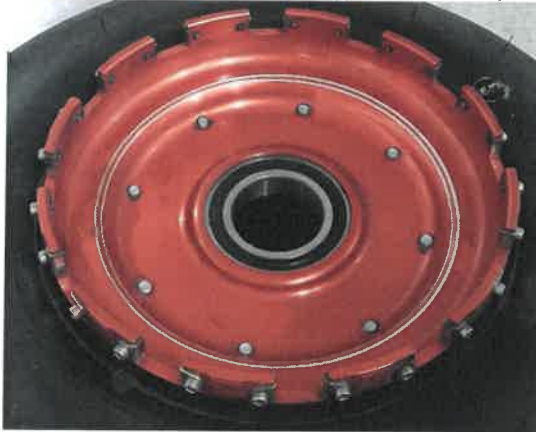
- Remove the wheel and tire assembly per the instructions in the applicable maintenance manual.
- Inspect the inner wheel half for circular scratches. An inner wheel half with a continuous circular scratch that has removed the anodizing must be replaced.

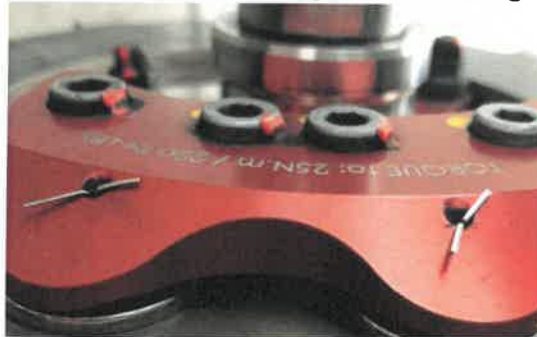
- This scratch has been caused by cotter pins that have been displaced from the initial orientation which is set and controlled during manufacturing.

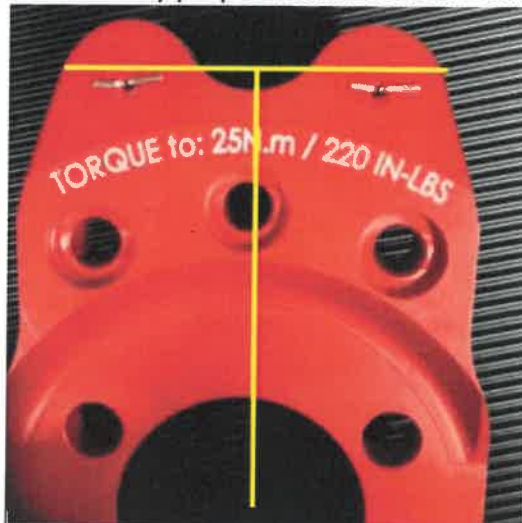
- The cotter pin tails must be nearly perpendicular to a line drawn vertically through the axle.
