SERVICE BULLETIN

SB-019

Replacement of Backstop BTR-001 in order to put the cotter-pin (ISO1234) backward (**BERINGER reference: L-V-011**). The goal is to prevent scratching of the inner wheel half by the tails of the cotter pin.

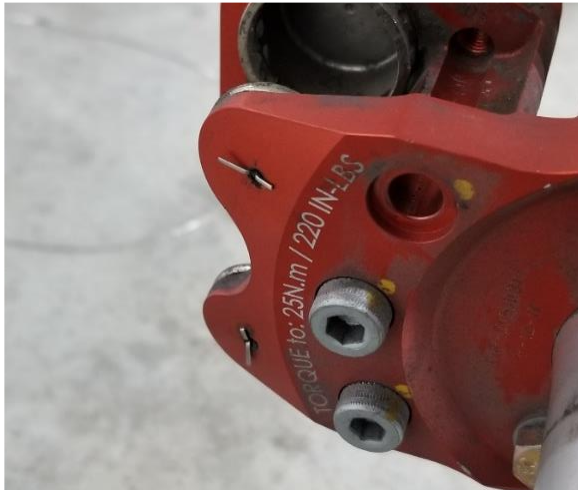
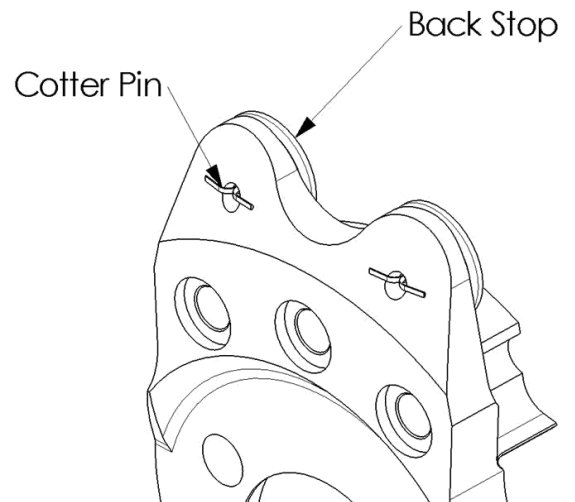
The cotter pin securing the back stop on the brake assembly back plate can be displaced from the as installed position. This can occur during unpackaging and first installation, maintenance, or at any other time when the parts are handled. If the cotter pin tails are raised from the surface of the back plate or rotated 90° from the initial orientation then they are at risk for contacting the inner wheel half and scratching the anodized finish.
