## SERVICE BULLETIN

SB-019

Replacement of Backstop BTR-001 in order to put the cotter-pin (ISO1234) backward (BERINGER reference: L-V-012 or Industry standard MS24665-071). The goal is to prevent scratching of the inner wheel half by the tails of the cotter pin.

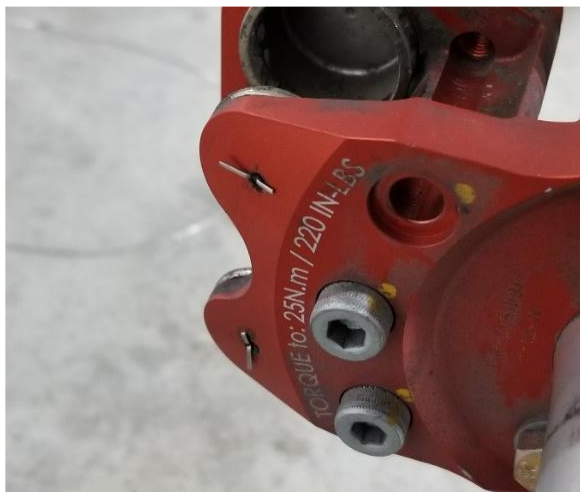
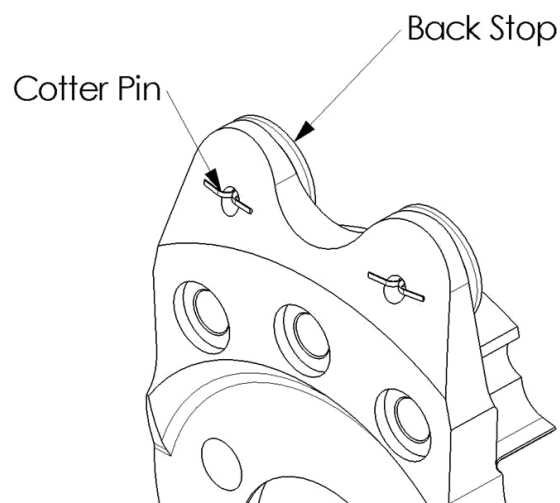
The cotter pin securing the back stop on the brake assembly back plate can be displaced from the as installed position. This can occur during unpackaging and first installation, maintenance, or at any other time when the parts are handled. If the cotter pin tails are raised from the surface of the back plate or rotated 90° from the initial orientation then they are at risk for contacting the inner wheel half and scratching the anodized finish.

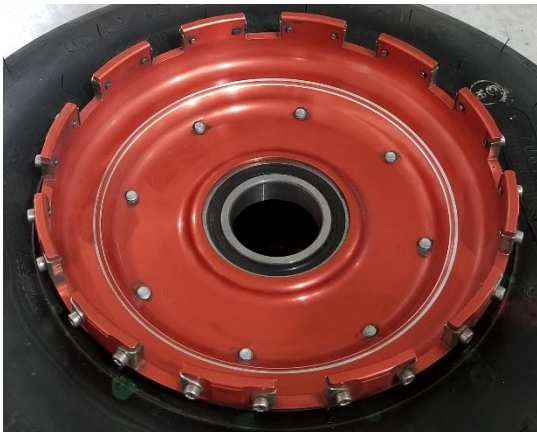
- Remove the wheel and tire assembly per the instructions in the applicable maintenance manual.
- Inspect the inner wheel half for circular scratches. Refer to SM-02 for wheel half scratch compliance.

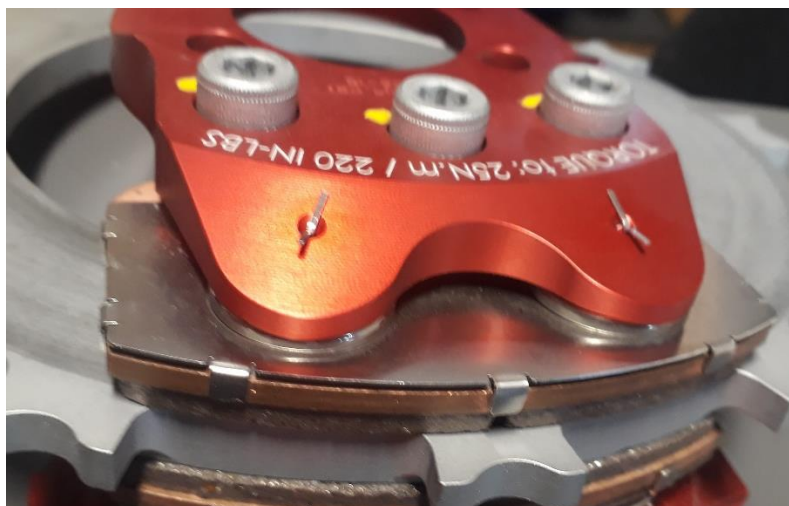
- This scratch has been caused by cotter pins that have been displaced from the initial orientation which is set and controlled during manufacturing.
