MAINTENANCE MANUAL

ICA and II

STC number:
ST02078AK-A

MM-STC-018

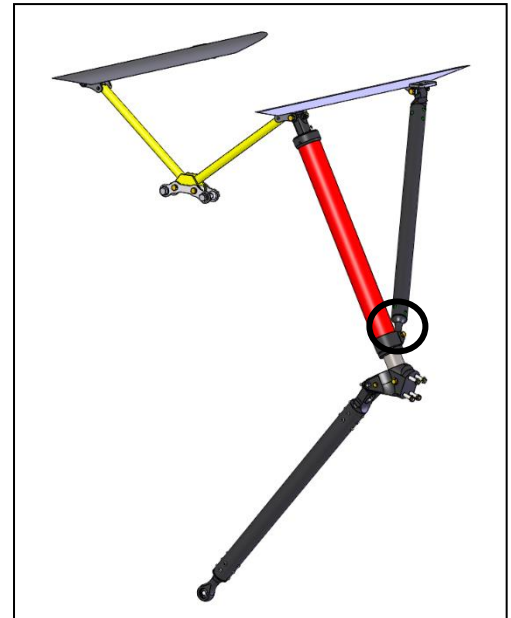
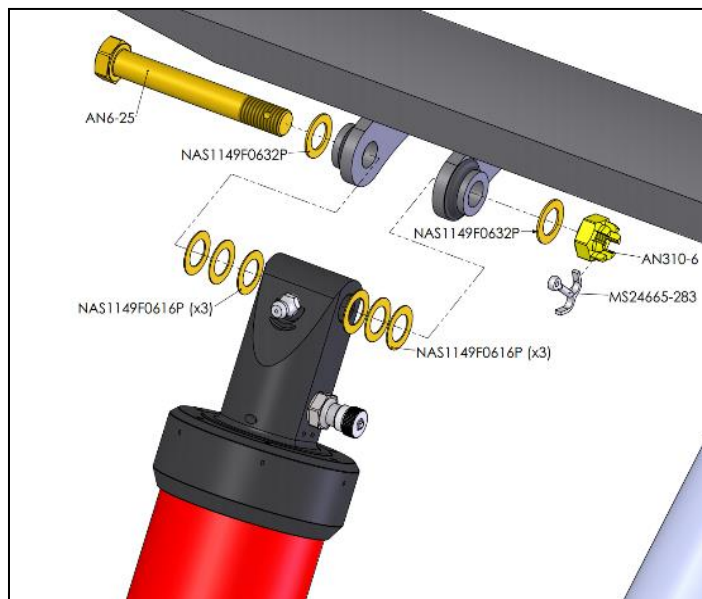
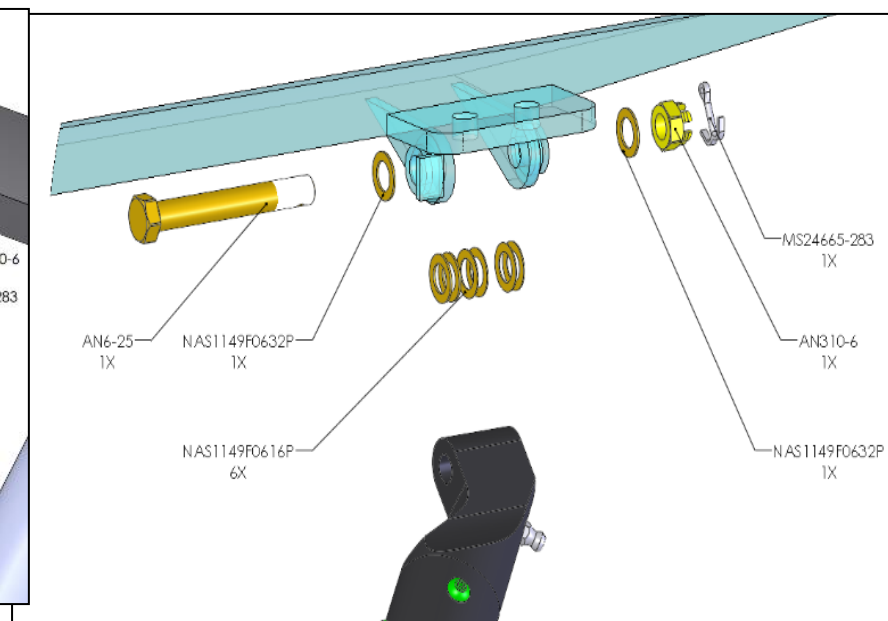
2.2 Installation of One Side

1. Locate the either the left or the right landing gear assembly: LG-T-006L or LG-T-006R.
2. Use the hardware included to install to the aircraft as shown in the two images below. Use or adjust washers as necessary.
3. Torque the AN5-15A fastener circled in the adjacent picture.
4. Apply grease using the grease fittings (4Places)
5. The picture to the right shows what the installation should look like at this point.
6. Repeat steps 1-4 for the opposite side.

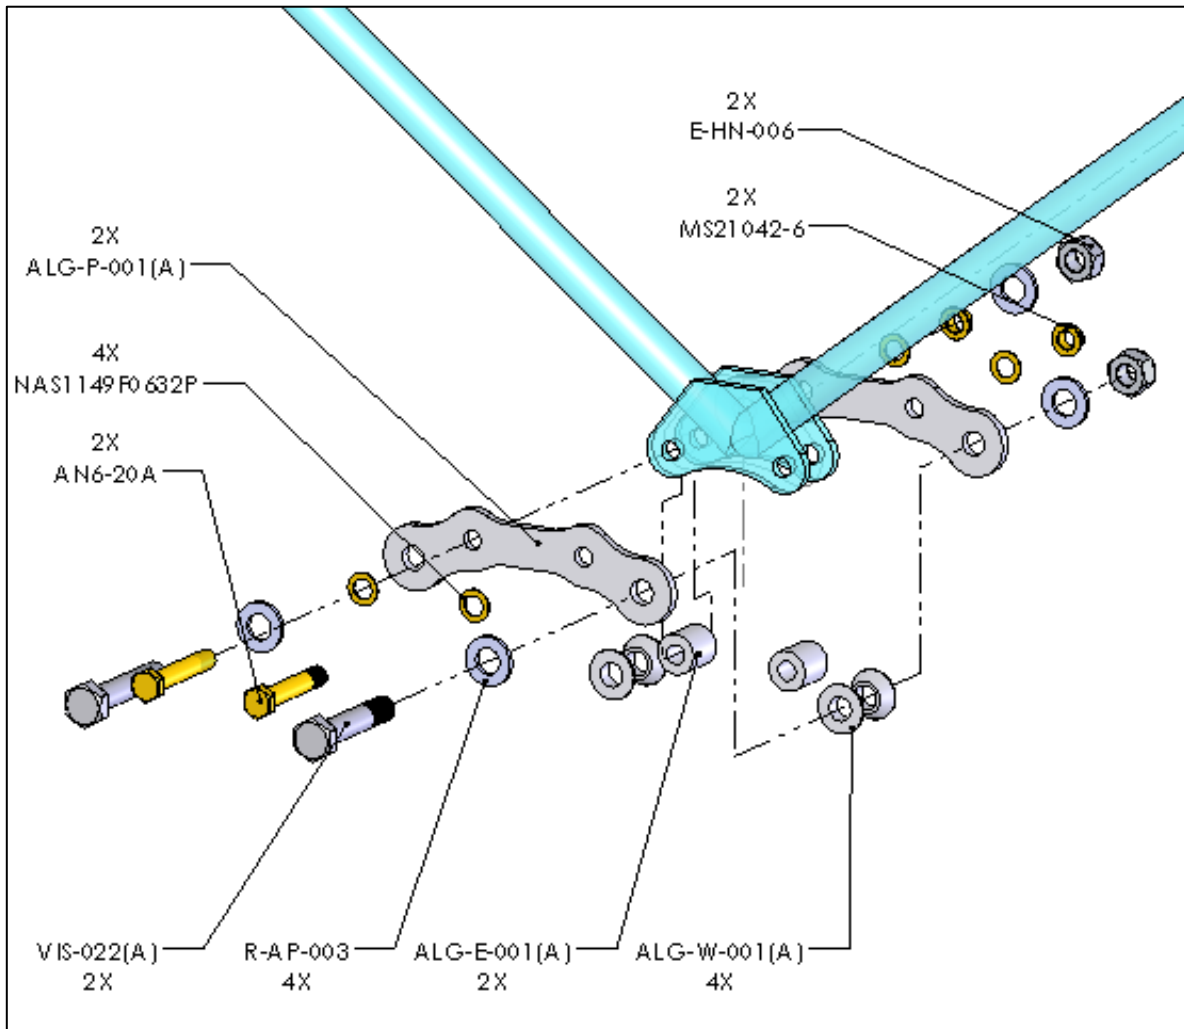
2.3 Installation of Cabane Plate Assembly

1. Connect the cabane plate assembly to the existing cabane vee as shown in the image below.
Do not tighten VIS-022, this will be done in the next step.

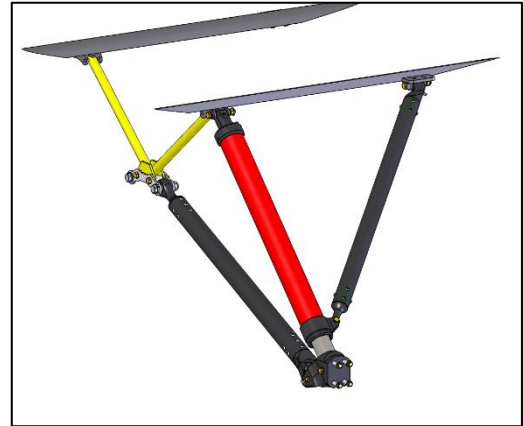
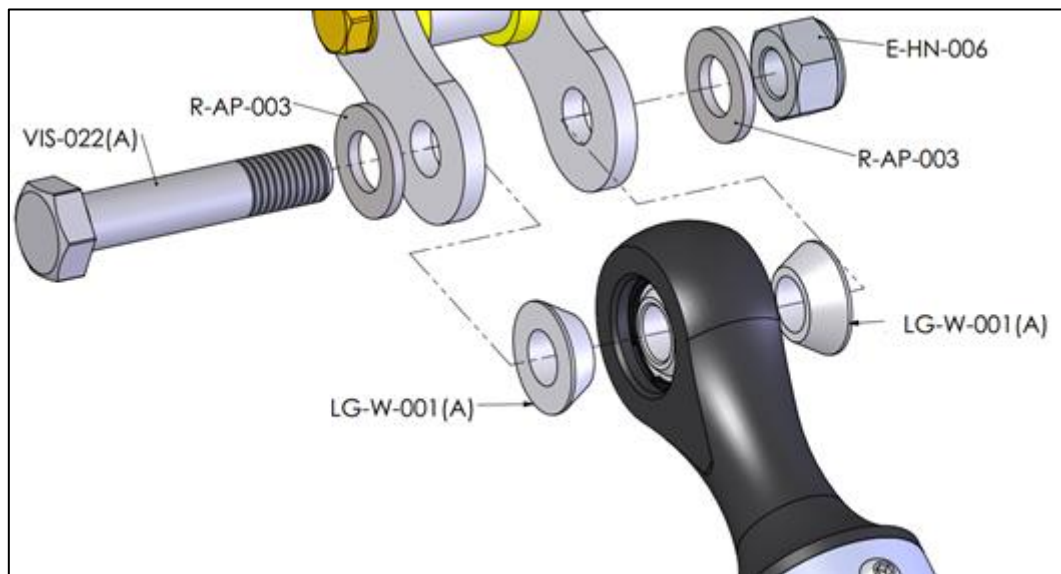
2.4 Installation of the Traction Leg

1. Connect the traction leg to the cabane plate assembly with the 2 conical spacers LG-W-001 on each side of the ball joint oriented as shown in the picture below.
2. Torque the bolt, VIS-022, to 62 ft-lbs (84 N.m).
3. The picture to the right shows what the installation should look like at this point.
4. Repeat step 1-2 for the opposite side.

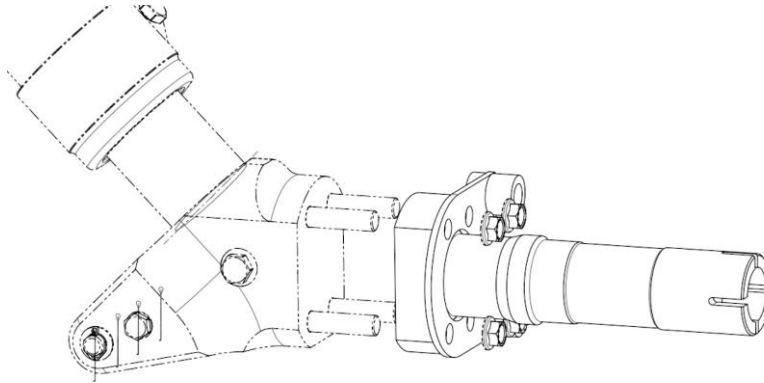
2.5.1 Axle type 1" 1/2 axle (with ABI or Cleveland wheels and brakes):

1. Only the following wheel and brake kits can be installed with this axle:
Alaskan Bushwheels part number: ABI-199-62 or ABI-199-62A
Cleveland part number: 199-62 or 199-62A
2. Install the axle, anchor plate, and brake caliper together onto the studs as shown in the picture below(caliper not shown in picture).
3. Torque the MS21042-6 nuts.
4. New axle nuts should be used each time the axle is removed for servicing or replacement.
5. Repeat steps 1-4 for the opposite side.

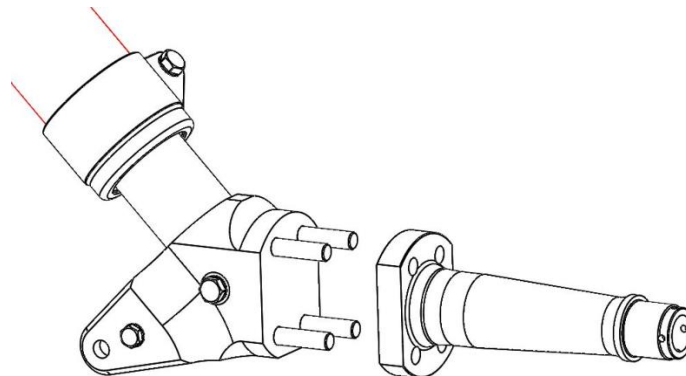
2.5.2 Axle type BERINGER Tapered Axle (with BERINGER wheel and brake assembly) :

1. Mount the axle onto the studs as shown in the picture below.
2. Torque the MS21042-6 nuts.
3. New axle nuts should be used each time the axle is removed for servicing or replacement.
4. Repeat steps 1-2 for the opposite side.
5. Install Beringer wheel RF-15.2 with brake EA-003.2N as defined by ETSO authorization EASA.210.10063244 and per the associated user manual UM-ETSO-008.

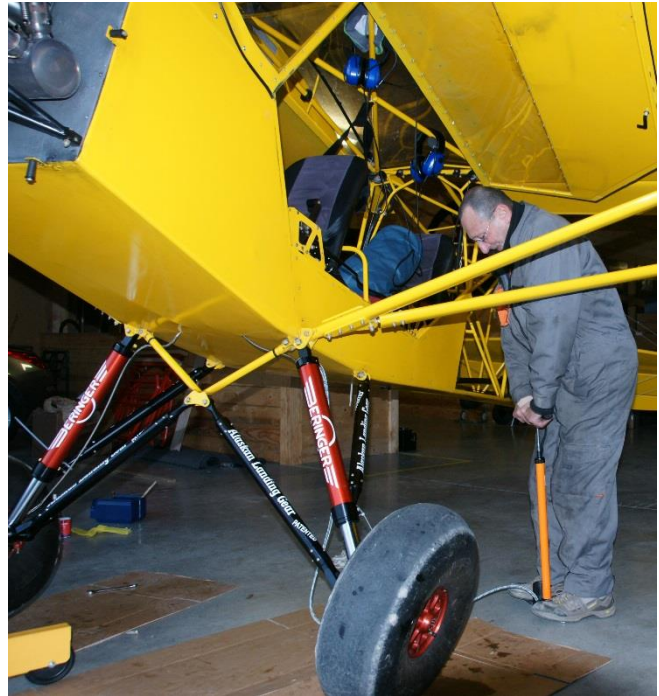
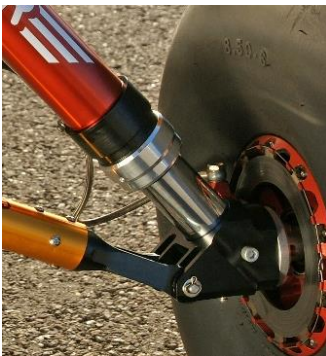
3 Shock Pressure

1. Use only a high-pressure shock pump. The aircraft must be lifted so that the landing gear is unloaded.
2. Thread the fitting of the pump onto the valve on the shock.
3. Inflate the shock to 270 Psi (18 bar)
4. Disconnect the pump
5. Set the aircraft on the ground and record the distance of extension of each chrome tube at the aircraft weight for future reference.

Do not reduce air pressure with the shock weighted. Oil can potentially be forced out of the valve.

Do not adjust pressure on a bench. The gear must be relatively vertical and unloaded during pressure adjustments or oil can potentially be forced out of the valve.

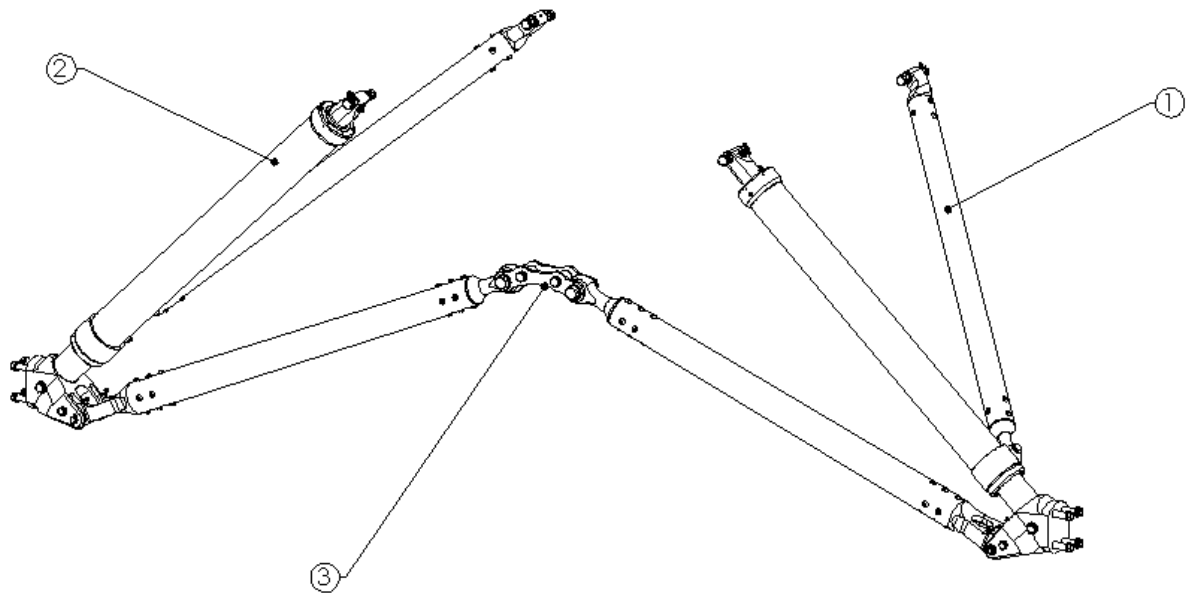
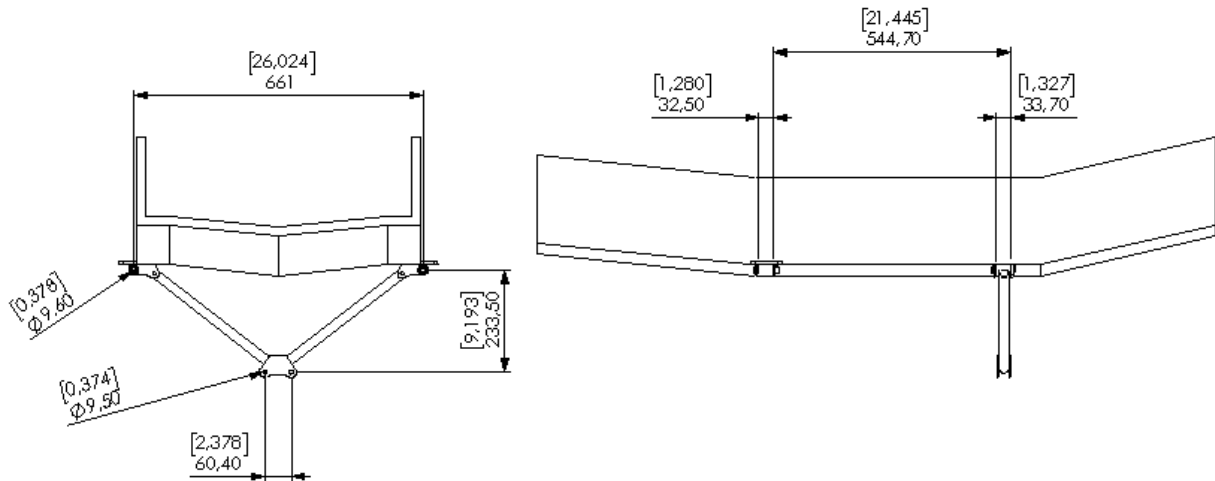
6.1 Complete BERINGER Alaskan Landing Gear Assembly

PA-18 FUSELAGE ATTACH POINTS SHOWN FOR REFERENCE ONLY

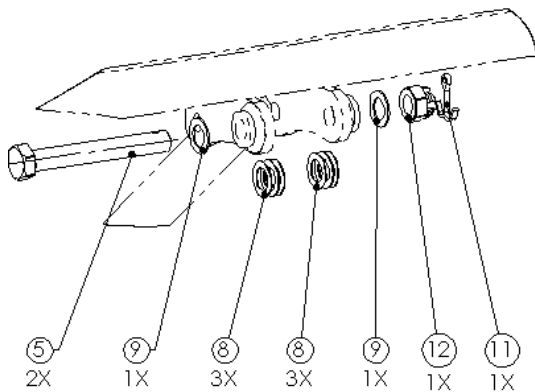
DÉTAIL B
ECHELLE/SCALE 2 : 5

SHOCK BOLT ASSY/VISSERIES AMORTISSEUR

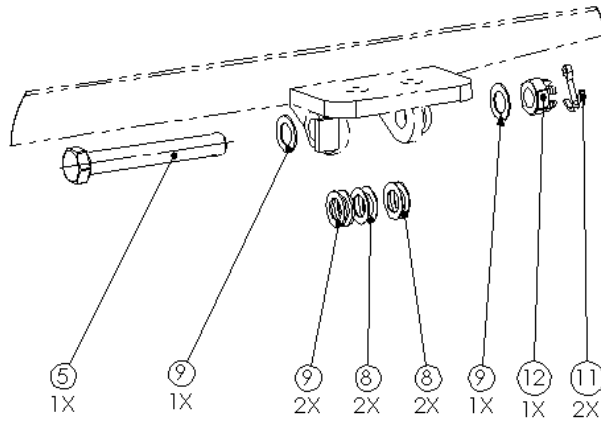
DÉTAIL A
ECHELLE/SCALE 2 : 5

STIFFENER BOLT ASSY/VISSERIES BILETTE

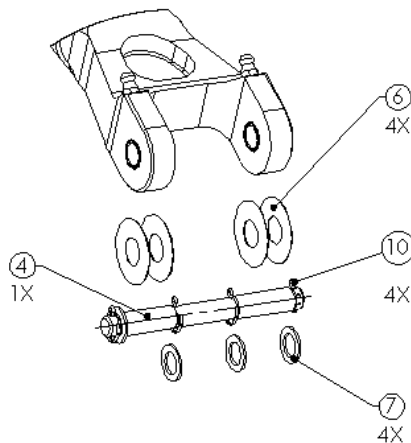
DÉTAIL C
ECHELLE/SCALE 2 : 5

TRACTION LEG BOLT ASSY/VISSERIES JAMBE DE TRACTION
