SERVICE BULLETIN

SB-019

Replacement of Backstop BTR-001 in order to put the cotter-pin (ISO1234) backward (**BERINGER reference: L-V-011**). The goal is to prevent scratching of the inner wheel half by the tails of the cotter pin.

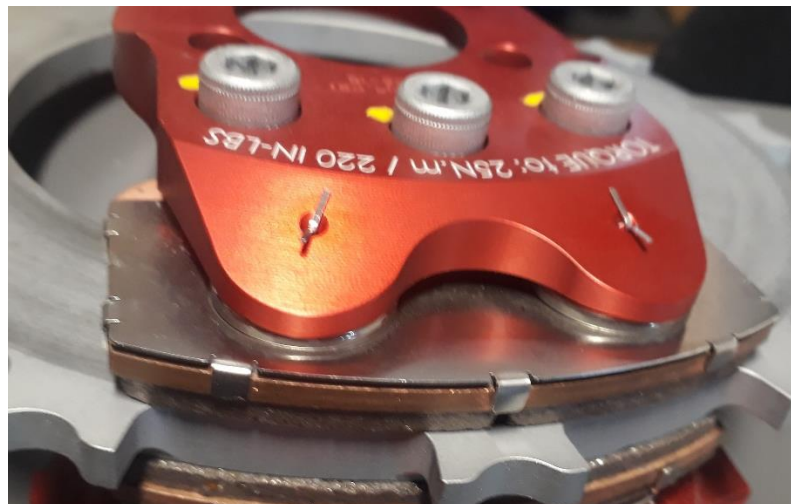
- This scratch has been caused by cotter pins that have been displaced from the initial orientation which is set and controlled during manufacturing.
