TIME LIMITS / MAINTENANCE CHECKS

Manuel référence :
BRG-ALTP-02

Référence document :
MC-STC-007

Statut (à compléter, terminé, approuvé)	Signature du responsable conception
Discus 2a, Ventus 2a				
Révisions	Date	Sujet		
0	12.09.201 2	Initial edition		
1	14.01.201 4	Change of wheel P/N, update of procedures		
2	30.06.201 7	Update with new wheel P/N	Terminé

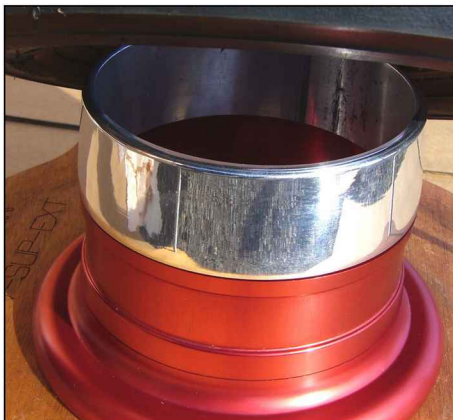
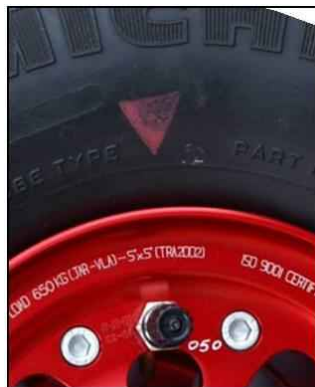
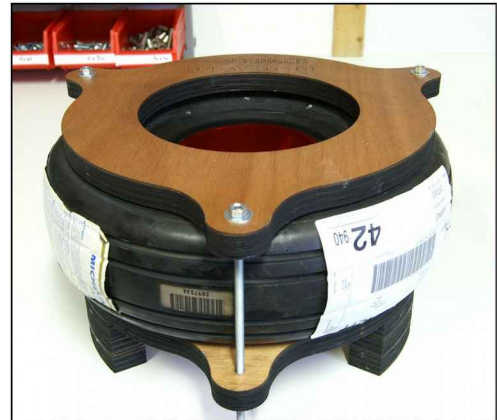
- c) Place the outer wheel half on the plywood tool.
- d) Insert the conical bushing made from polished aluminium on the central spacer.
- e) Spray tire lubricant on the tire beads and on the conical bushing
- f) Insert the tire on the assembly with red spot in front of the valve
- g) Place the second part of the plywood tool on the assembly and screw the 3 butterfly nuts. Press the tire till the conical bushing can be removed.

- h) Place the inner wheel flange on the table and position the large o-ring in the groove.
- i) Return the plywood tool with assembly onto the inner wheel flange. Position the assembly so that bolt holes are aligned.

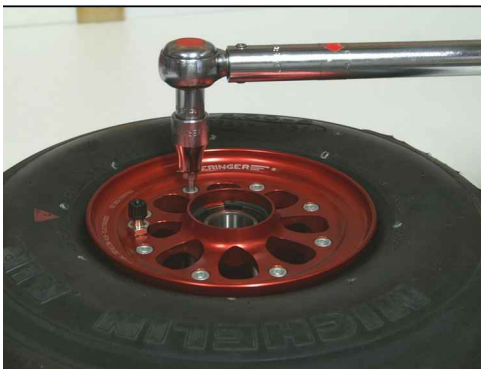
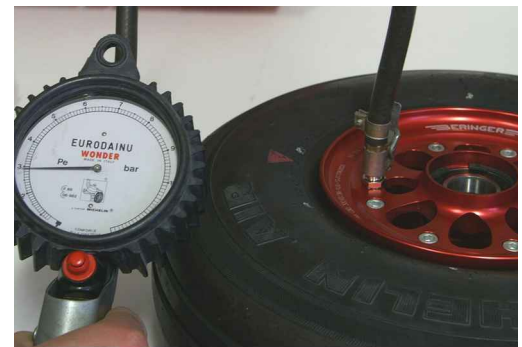
l) Then torque tighten with a torque wrench to 10 N.m (87 in-lbs)

NOTE: Respect the order when torque tightening

m) Torque tighten a second time each screw

CAUTION: Do not use impact or power wrenches
